THERMOGRAPHIC INSPECTION

JOB #: 1575-M1

ITEM: Freezer Door

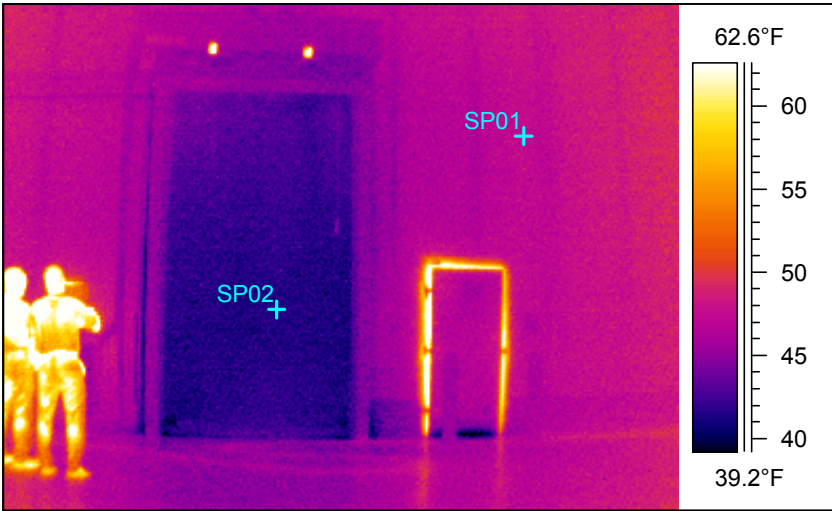
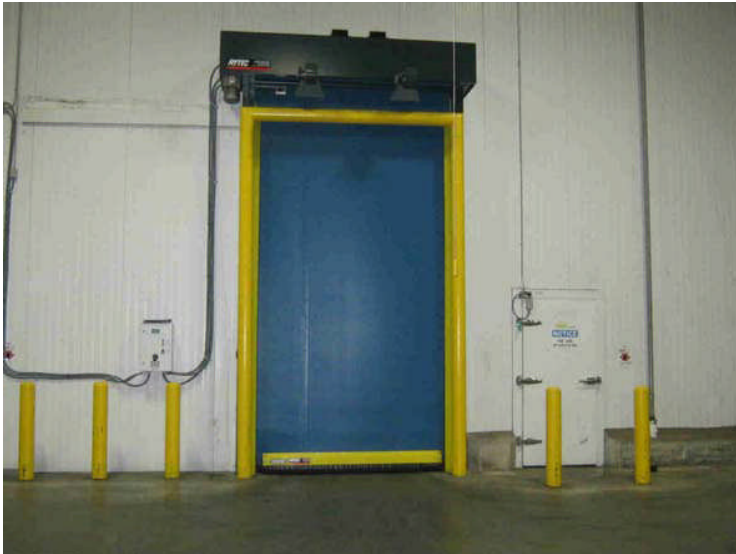
PICTURE #: 13

Label	Value
SP01	47.8°F
SP02	42.1°F

Emissivity	0.95
Object Distance	20.0 ft
Ambient Temp.	44.0°F
Imager Model	AGEMA 550 NTSC

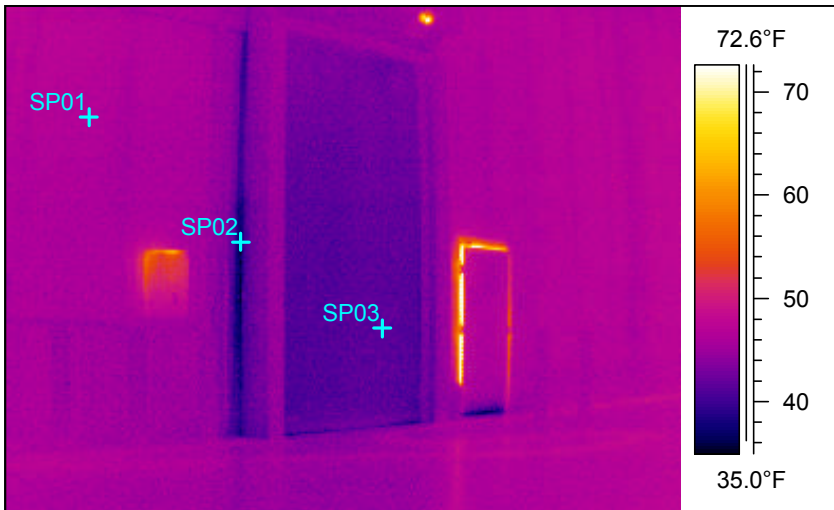
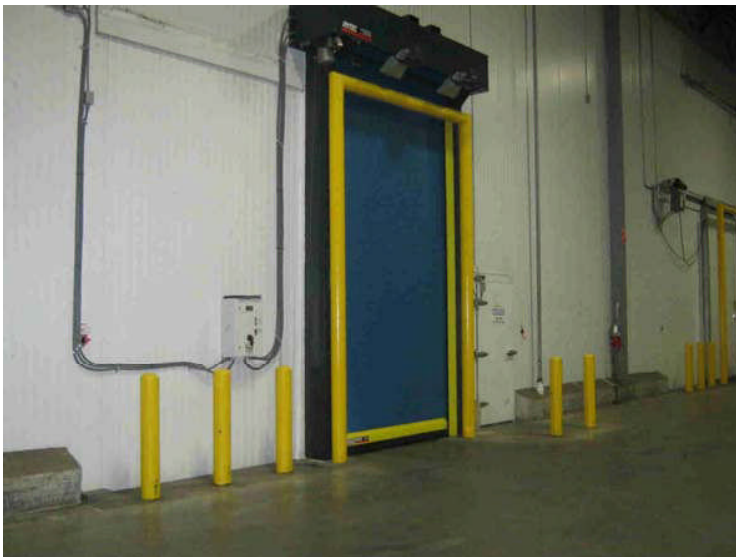
PICTURE #: 14

ITEM: Freezer Door

Label	Value
SP01	47.2°F
SP02	37.4°F
SP03	41.6°F

Emissivity	0.95
Object Distance	20.0 ft
Ambient Temp.	44.0°F
Imager Model	AGEMA 550 NTSC
